RE: Navion Fuel Systems.- N91472

SERVICE BULLETIN

Model A73V and A73 W
Fuel Selector Valves

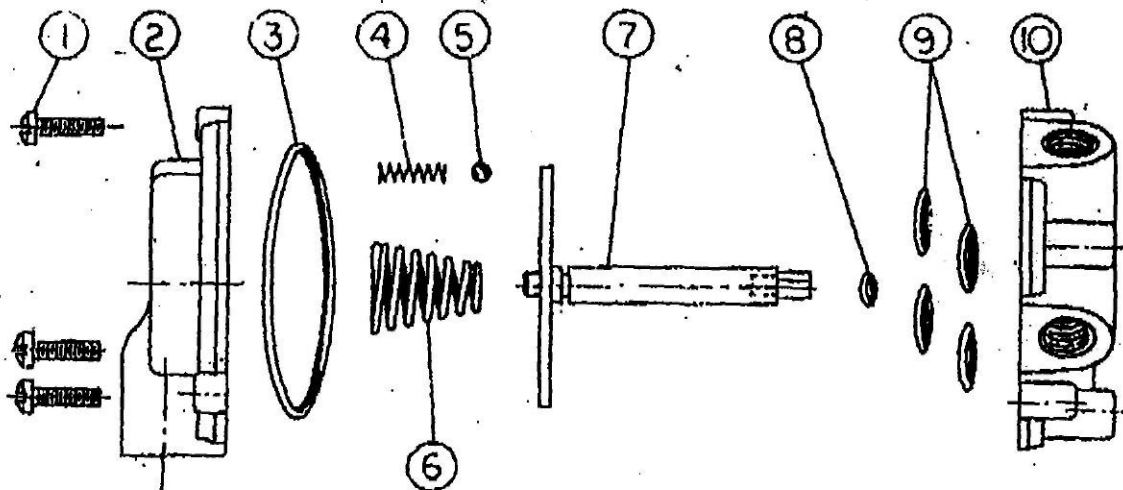
One of the items we attended to was the overhaul of the fuel selector valve. While the valve did not leak air into the fuel lines, it did permit fuel to drain from the right tip tank into the mains while the valve was in the "off" position. Upon disassembly, we found that the "O"-rings sealing each port on the valve body were old, hard, cracked and portions were missing. We obtained the Hoof Products Company Service Bulletin for the Model A73V valve, and followed their procedures and specifications for o-rings in servicing the unit. Since the first overhaul in 1992, I have had the valve overhauled twice more, to assure that the o-rings do not deteriorate to the condition I found them in when we purchased the aircraft.

Remove the three screws (1) and carefully separate the Cover (2) from Body (10). Remove Valve Assembly (7) from Body (10). Remove all "O" Rings.

Clean all parts in a cleaning solvent, Federal Specification F-3-661. Inspect all parts for wear or damage, and replace as required. Replace "O" Rings (3), (8), and (9).

Re-assemble the valve, packing the "O" Rings with "Petrolatum".

Rotate the control shaft through two complete turns clockwise and through two complete turns counter-clockwise. There should be no binding.

At each port position, there should be a positive "feel" stop. Turn the valve to the "off" position and pressure test each port with 20 psi air to check for leaks. Submerge the valve in Odorless Mineral Spirits to detect air leaks. There should be no leakage, external or internal.
